**Flood Control Project Maintenance
Levee Inspections**

Maintenance Issue Types Only, Levee Inspection Report By Mile - Spring 2019

Reclamation District No. 1500 Sutter Basin

Waterway	Bank	Unit Miles	Inspection Start/End	Inspector
Unit No. 01 Sacramento River	Left	33.15	04/24/2019 04/26/2019	Zach Jojola

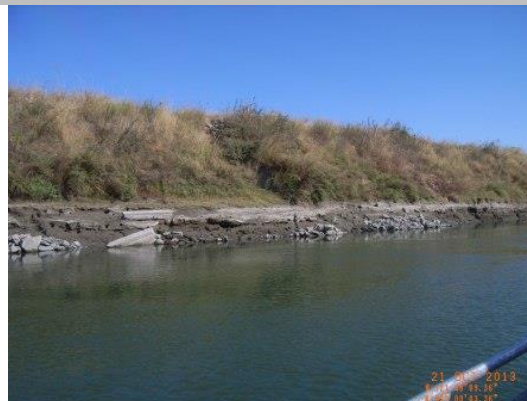
Photo 1 of 1 : SP_2019_RD1500_189_82_20190304_00033.jpg

LM Start	30.60	Rating **	A/W	Issue No.	82
LM End	30.75	Issue Type +	Ma	Location *	WS
Category	Supplemental			GPS Latitude/Longitude	
				Start	End
Item	2017 USACE Erosion Survey, DRAFT			38.999745 °	39.001413 °
				-121.800898 °	-121.802889 °
DWR ID	DWR_RD1500_01_f_2018_82				
Comment Code					
Inspector Comment					
2017 Site ID: SAC 116.0 L					
Status: Eroding					
2017 Field Notes: Minor new erosion throughout the site.					
Site History: 2000 - Eroding, vertical berm slope over a vertical cohesive toe; slow erosion but getting close to the toe. 2002 - Erosion is getting close to the levee, still eroding with some new small slumps. 2004 - Some minor new erosion. 2006 - Some new erosion, cleaned off older scars and slump faces. 2008 - New, small, partial rotational failure. 2011 - Some new minor erosion. 2016 - Fresh erosion on lower bank.

USACE 2013 Photo #1

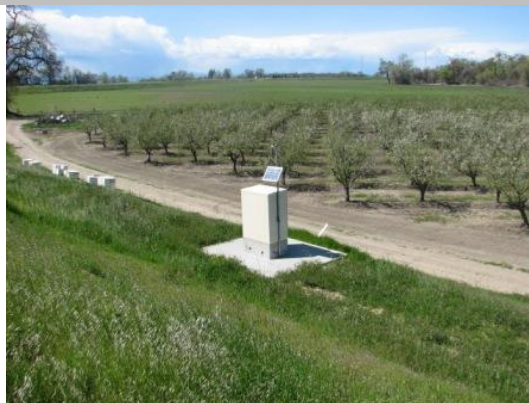
Photo 2 of 2 : SP_2019_RD1500_189_86_20190304_00039.jpg

LM Start	31.54	Rating **	A/W	Issue No.	86 (cont)	
LM End	31.54	Issue Type +	Ma	Location *	LS	
Category	Earthen Levee			GPS Latitude/Longitude		
				Start		End
Item	Encroachments			39.006687 °		39.006687 °
				-121.814967 °		-121.814967 °
DWR ID	DWR_RD1500_01_s_2016_86					
Comment Code						
MW : Monitoring Well						
Inspector Comment						
UCIP installed this monitoring station for seepage in the area. Monitor for vandalism or damage PN: (18630).

The control unit for pizometers installed in 2012, photo taken spring 2012.

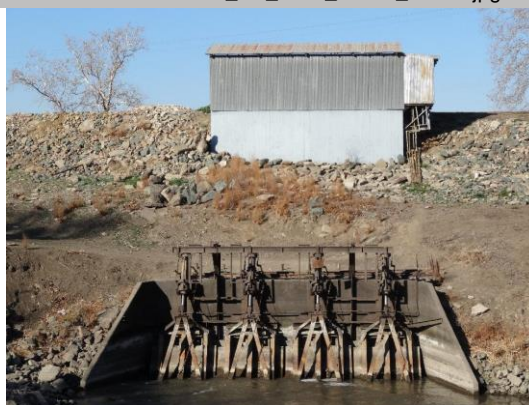
Photo 1 of 3 : UCIP_SP_2019_28886_53098.jpg

Comment Code					
Inspector Comment					
FS_ID:28886 DS_ID:20020 EP_NO: N/A Repair Type: No Action Needed Crossing Status: Found UCIP Comments: Pumping plat was working during the field visit.Hydraulic gates on outfall structure. Motorized slide gates on waterside shoulder. FIELD_STRUCT_DESC: [Reclamation District No. 1500, Pumping Plant No. 3] 1 of 4: 72-inch by 84-inch reinforced concrete box drainage discharge conduit under the levee, 35 feet below the crown. Two concrete cutoff walls. Pumps in concrete pumping plant on the landside (LS). Timber steps on the LS slope. Two service poles and anchors on the LS shoulder. Electrical control gates in a metal and concrete building on the waterside (WS) shoulder. Flap gates on the WS end. Installed by USACE in 1950. (Construction of a four compartment concrete gravity outlet conduit under the levee authorized under Permit No. 1284, 1948 - Reclamation District No. 1500). [Additional Reference(s): DWR Levee Log, 1993. USACE Sacramento O&M Manual 129, June 1954, (Station 1227+00)]. FS Date: 1/21/2014

WS view: CM shed for slide gate on levee shoulder (top) and outfall structure at levee toe (bottom).

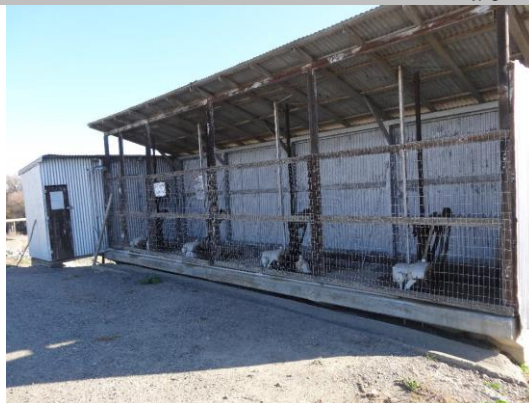
Photo 2 of 3 : UCIP_SP_2019_28886_53096.jpg

WS view: motorized slide gates in CM shed on levee shoulder.

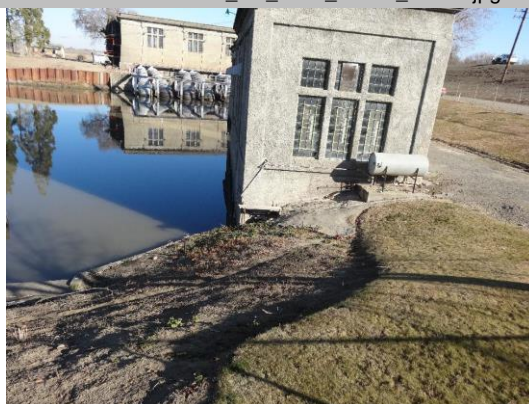
Photo 3 of 3 : UCIP_SP_2019_28886_53097.jpg

LS view: pump house at the end of levee berm.

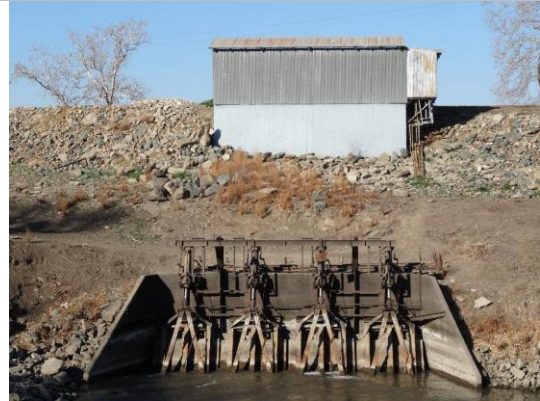
Photo 1 of 3 : UCIP_SP_2019_28883_53085.jpg

Comment Code						
Inspector Comment						
FS_ID:28883						
DS_ID:20027						
EP_NO: N/A						
Repair Type: No Action Needed						
Crossing Status: Found						
UCIP Comments: Pumping plat was working during the field visit. Hydraulic gates on outfall structure. Motorized slide gates on waterside shoulder.						
FIELD_STRUCT_DESC: [Reclamation District No. 1500, Pumping Plant No. 3] 2 of 4: 72-inch by 84-inch reinforced concrete box drainage discharge conduit under the levee, 35 feet below the crown. Two concrete cutoff walls. Pumps in concrete pumping plant on the landside (LS). Timber steps on the LS slope. Two service poles and anchors on the LS shoulder. Electrical control gates in a metal and concrete building on the waterside (WS) shoulder. Flap gates on the WS end. Installed by USACE in 1950. (Construction of a four compartment concrete gravity outlet conduit under the levee authorized under Permit No. 1284, 1948 - Reclamation District No. 1500). [Additional Reference(s): DWR Levee Log, 1993. USACE Sacramento O&M Manual 129, June 1954, (Station 1227+00)].

WS view: CM shed for slide gate on levee shoulder (top) and outfall structure at levee toe (bottom).

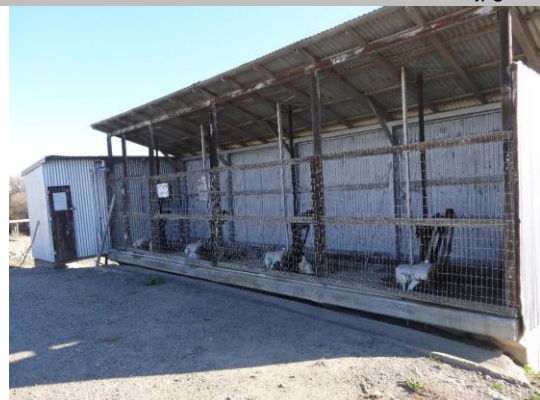
Photo 2 of 3 : UCIP_SP_2019_28883_53083.jpg

WS view: motorized slide gates in CM shed on levee shoulder.

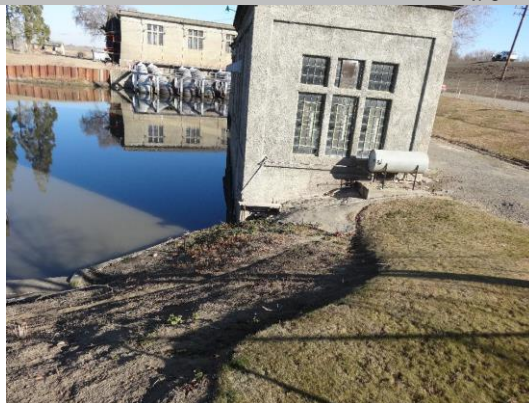
Photo 3 of 3 : UCIP_SP_2019_28883_53084.jpg

Comment Code					
Inspector Comment					
FS_ID:28883 DS_ID:20027 EP_NO: N/A Repair Type: No Action Needed Crossing Status: Found UCIP Comments: Pumping plat was working during the field visit.Hydraulic gates on outfall structure. Motorized slide gates on waterside shoulder. FIELD_STRUCT_DESC: [Reclamation District No. 1500, Pumping Plant No. 3] 2 of 4: 72-inch by 84-inch reinforced concrete box drainage discharge conduit under the levee, 35 feet below the crown. Two concrete cutoff walls. Pumps in concrete pumping plant on the landside (LS). Timber steps on the LS slope. Two service poles and anchors on the LS shoulder. Electrical control gates in a metal and concrete building on the waterside (WS) shoulder. Flap gates on the WS end. Installed by USACE in 1950. (Construction of a four compartment concrete gravity outlet conduit under the levee authorized under Permit No. 1284, 1948 - Reclamation District No. 1500). [Additional Reference(s): DWR Levee Log, 1993. USACE Sacramento O&M Manual 129, June 1954, (Station 1227+00)]. FS Date: 1/21/2014

LS view: pump house at the end of levee berm.

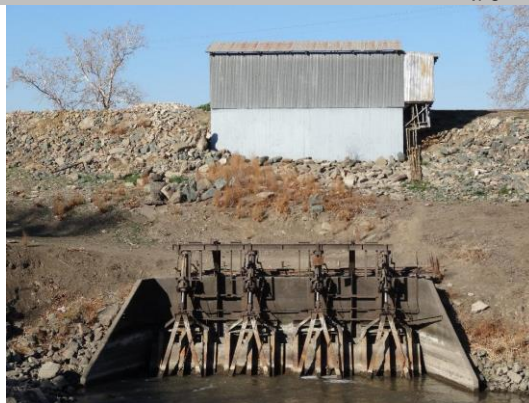
Photo 1 of 3 : UCIP_SP_2019_28884_53089.jpg

Comment Code					
Inspector Comment					
FS_ID:28884 DS_ID:20028 EP_NO: N/A Repair Type: No Action Needed Crossing Status: Found UCIP Comments: Pumping plat was working during the field visit.Hydraulic gates on outfall structure. Motorized slide gates on waterside shoulder. FIELD_STRUCT_DESC: [Reclamation District No. 1500, Pumping Plant No. 3] 3 of 4: 72-inch by 84-inch reinforced concrete box drainage discharge conduit under the levee, 35 feet below the crown. Two concrete cutoff walls. Pumps in concrete pumping plant on the landside (LS). Timber steps on the LS slope. Two service poles and anchors on the LS shoulder. Electrical control gates in a metal and concrete building on the waterside (WS) shoulder. Flap gates on the WS end. Installed by USACE in 1950. (Construction of a four compartment concrete gravity outlet conduit under the levee authorized under Permit No. 1284, 1948 - Reclamation District No. 1500). [Additional Reference(s): DWR Levee Log, 1993. USACE Sacramento O&M Manual 129, June 1954, (Station 1227+00)]. FS Date: 1/21/2014

WS view: CM shed for slide gate on levee shoulder (top) and outfall structure at levee toe (bottom).

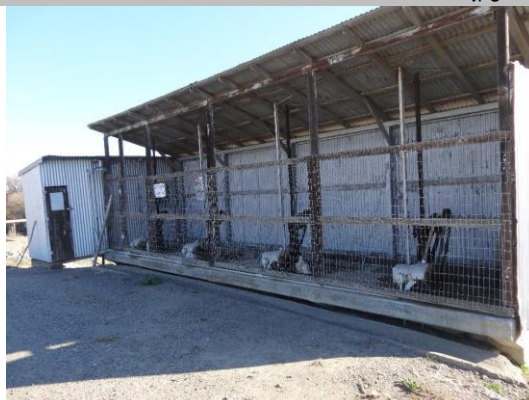
Photo 2 of 3 : UCIP_SP_2019_28884_53088.jpg

WS view: motorized slide gates in CM shed on levee shoulder.

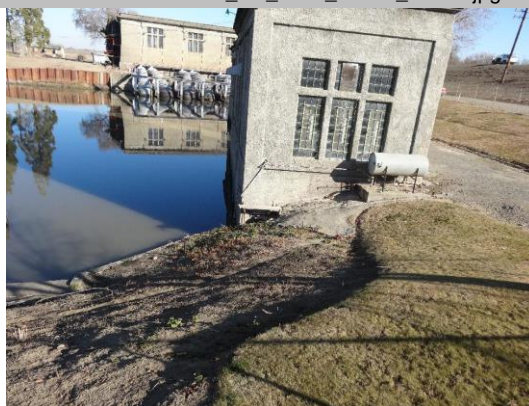
Photo 3 of 3 : UCIP_SP_2019_28884_53099.jpg

Comment Code					
Inspector Comment					
FS_ID:28884 DS_ID:20028 EP_NO: N/A Repair Type: No Action Needed Crossing Status: Found UCIP Comments: Pumping plat was working during the field visit.Hydraulic gates on outfall structure. Motorized slide gates on waterside shoulder. FIELD_STRUCT_DESC: [Reclamation District No. 1500, Pumping Plant No. 3] 3 of 4: 72-inch by 84-inch reinforced concrete box drainage discharge conduit under the levee, 35 feet below the crown. Two concrete cutoff walls. Pumps in concrete pumping plant on the landside (LS). Timber steps on the LS slope. Two service poles and anchors on the LS shoulder. Electrical control gates in a metal and concrete building on the waterside (WS) shoulder. Flap gates on the WS end. Installed by USACE in 1950. (Construction of a four compartment concrete gravity outlet conduit under the levee authorized under Permit No. 1284, 1948 - Reclamation District No. 1500). [Additional Reference(s): DWR Levee Log, 1993. USACE Sacramento O&M Manual 129, June 1954, (Station 1227+00)]. FS Date: 1/21/2014

LS view: pump house at the end of levee berm.

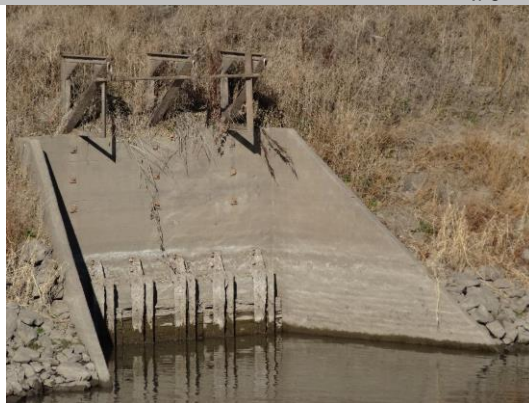
Photo 1 of 3 : UCIP_SP_2019_28954_53260.jpg

Comment Code						
Inspector Comment						
FS_ID:28954 DS_ID:20019 EP_NO: 10088 Repair Type: No Action Needed Crossing Status: Found UCIP Comments: USED Bench Mark on concrete structure at waterside shoulder. FIELD_STRUCT_DESC: [Reclamation District No. 1500, Pumping Plant No. 2] 1 of 3: 48-inch by 48-inch reinforced concrete box drainage discharge conduit under the levee, 37 feet below the crown. Two concrete cutoff walls. Pumps in concrete pumping plant on the landside (LS). Slide gates mounted on a concrete structure on the waterside (WS) slope. Discharges in borrow pit. Flap gates on the WS end. (48-inch by 48-inch reinforced concrete box drainage discharge conduit under the levee and all other appurtenances retained under Automatic Board Order (ABO) issued as Permit No. 10088, 1974 - Reclamation District No. 1500). [Additional Reference(s): DWR Levee Log, 1993. USACE Sacramento O&M Manual 129, June 1954, (Station 1226+00)]. FS Date: 1/21/2014

WS view: U type concrete headwall and flap gates on levee toe.

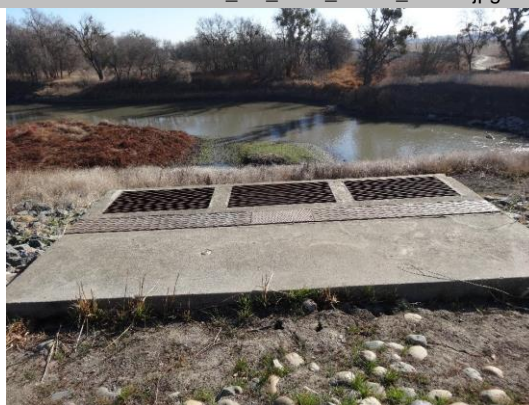
Photo 2 of 3 : UCIP_SP_2019_28954_53259.jpg

WS view: concrete surge structure on waterside shoulder.

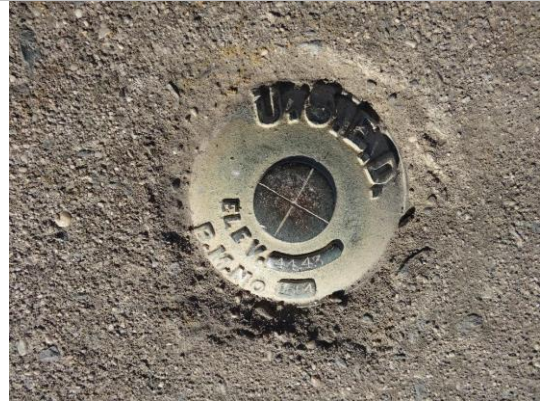
Photo 3 of 3 : UCIP_SP_2019_28956_53267.jpg

Comment Code						
Inspector Comment						
FS_ID:28956 DS_ID:20026 EP_NO: 10088 Repair Type: No Action Needed Crossing Status: Found UCIP Comments: USED Bench Mark on concrete structure at waterside shoulder. FIELD_STRUCT_DESC: [Reclamation District No. 1500, Pumping Plant No. 2] 3 of 3: 48-inch by 48-inch reinforced concrete box drainage discharge conduit under the levee, 37 feet below the crown. Two concrete cutoff walls. Pumps in concrete pumping plant on the landside (LS). Slide gates mounted on a concrete structure on the waterside (WS) slope. Discharges in borrow pit. Flap gates on the WS end. (48-inch by 48-inch reinforced concrete box drainage discharge conduit under the levee and all other appurtenances retained under Automatic Board Order (ABO) issued as Permit No. 10088, 1974 - Reclamation District No. 1500). [Additional Reference(s): DWR Levee Log, 1993. USACE Sacramento O&M Manual 129, June 1954, (Station 1226+00)]. FS Date: 1/21/2014

WS view: USED Bench Mark on concrete structure at levee shoulder.

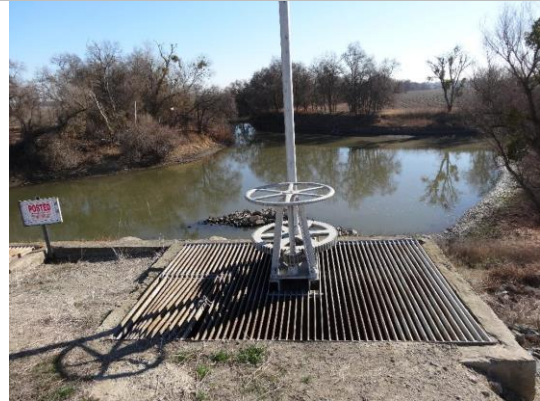
Photo 1 of 3 : UCIP_SP_2019_28891_53137.jpg

Comment Code					
Inspector Comment					
FS_ID:28891 DS_ID:20088 EP_NO: 10088 Repair Type: No Action Needed Crossing Status: Found UCIP Comments: Pumping plant was working during the field visit. Three 8.5 ft. X 8.5 ft. concrete box on waterside shoulder. FIELD_STRUCT_DESC: [Reclamation District No. 1500, Pumping Plant No. 1] 1 of 3: 84-inch by 84-inch reinforced concrete box drainage discharge conduit under the levee, 24 feet below the crown. Pumps in concrete pumping plant on the landside (LS). Slide gates mounted on a concrete structure on the waterside (WS) slope. Discharges in a concrete spillway and the borrow pit. Ramp on the WS slope. (84-inch by 84-inch reinforced concrete box drainage discharge conduit under the levee and all other appurtenances retained under Automatic Board Order (ABO) issued as Permit No. 10088, 1974 - Reclamation District No. 1500). [Additional Reference(s): DWR Levee Log, 2005. USACE Sacramento O&M Manual 129, June 1954, (Station 1224+75), three 78-inch concrete conduits referenced]. FS Date: 1/21/2014

WS view: slide gate in concrete box on levee shoulder.

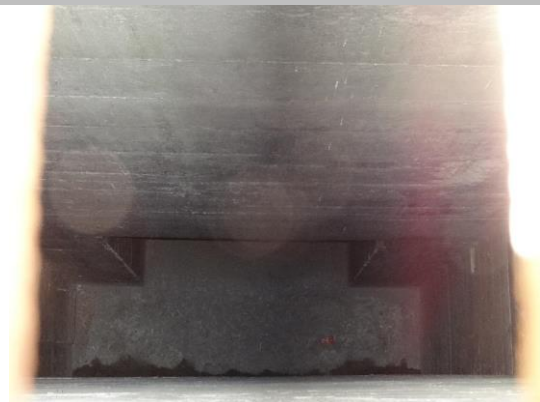
Photo 2 of 3 : UCIP_SP_2019_28891_53136.jpg

WS view: inside view of concrete box on levee shoulder.

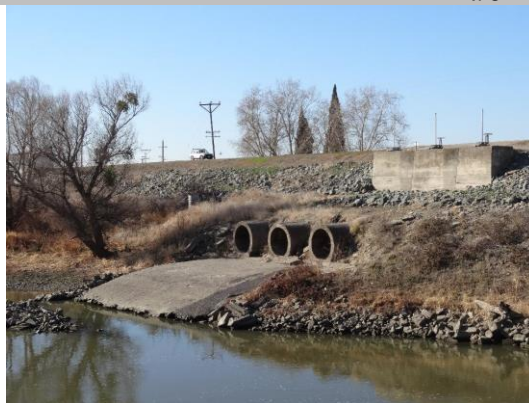
Photo 1 of 3 : UCIP_SP_2019_28892_53147.jpg

Comment Code					
Inspector Comment					
FS_ID:28892 DS_ID:20092 EP_NO: 10088 Repair Type: No Action Needed Crossing Status: Found UCIP Comments: Pumping plant was working during the field visit. Three 8.5 ft. X 8.5 ft. concrete box on waterside shoulder. FIELD_STRUCT_DESC: [Reclamation District No. 1500, Pumping Plant No. 1] 2 of 3: 84-inch by 84-inch reinforced concrete box drainage discharge conduit under the levee, 24 feet below the crown. Pumps in concrete pumping plant on the landside (LS). Slide gates mounted on a concrete structure on the waterside (WS) slope. Discharges in a concrete spillway and the borrow pit. Ramp on the WS slope. (84-inch by 84-inch reinforced concrete box drainage discharge conduit under the levee and all other appurtenances retained under Automatic Board Order (ABO) issued as Permit No. 10088, 1974 - Reclamation District No. 1500). [Additional Reference(s): DWR Levee Log, 2005. USACE Sacramento O&M Manual 129, June 1954, (Station 1224+75), three 78-inch concrete conduits referenced]. FS Date: 1/21/2014

WS view: outfall structure on levee toe and concrete box on levee shoulder.

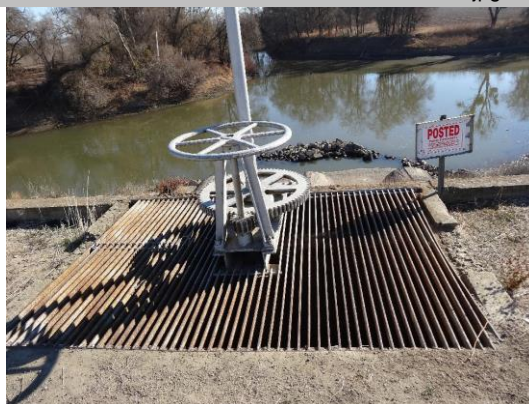
Photo 2 of 3 : UCIP_SP_2019_28892_53146.jpg

WS view: slide gate in concrete box on levee shoulder.

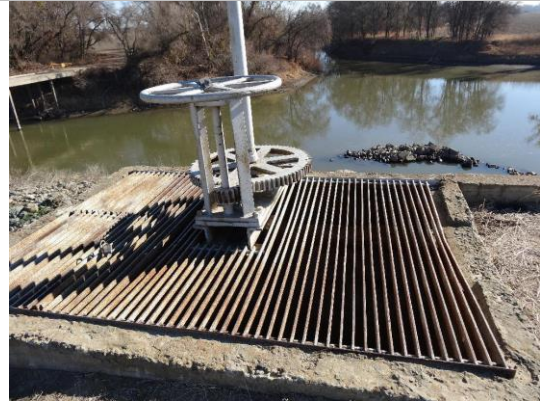
Photo 1 of 3 : UCIP_SP_2019_28893_53157.jpg

Comment Code						
Inspector Comment						
FS_ID:28893 DS_ID:20093 EP_NO: 10088 Repair Type: No Action Needed Crossing Status: Found UCIP Comments: Pumping plant was working during the field visit. Three 8.5 ft. X 8.5 ft. concrete box on waterside shoulder. FIELD_STRUCT_DESC: [Reclamation District No. 1500, Pumping Plant No. 1] 3 of 3: 84-inch by 84-inch reinforced concrete box drainage discharge conduit under the levee, 24 feet below the crown. Pumps in concrete pumping plant on the landside (LS). Slide gates mounted on a concrete structure on the waterside (WS) slope. Discharges in a concrete spillway and the borrow pit. Ramp on the WS slope. (84-inch by 84-inch reinforced concrete box drainage discharge conduit under the levee and all other appurtenances retained under Automatic Board Order (ABO) issued as Permit No. 10088, 1974 - Reclamation District No. 1500). [Additional Reference(s): DWR Levee Log, 2005. USACE Sacramento O&M Manual 129, June 1954, (Station 1224+75), three 78-inch concrete conduits referenced]. FS Date: 1/21/2014

WS view: slide gate in concrete box on levee shoulder.

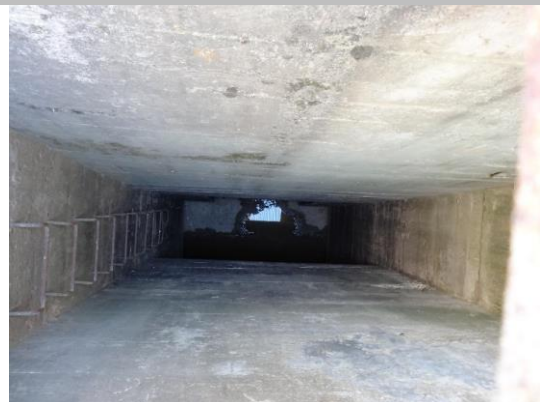
Photo 2 of 3 : UCIP_SP_2019_28893_53156.jpg

WS view: inside view of concrete box on levee shoulder.

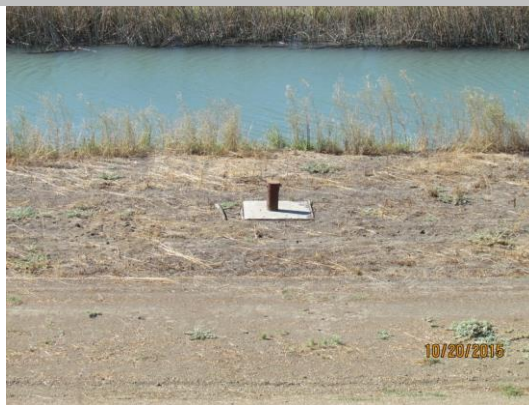
Photo 3 of 3 : SP_2019_RD1500_190_4_20190304_00003.jpg

LM Start	14.13	Rating **	U	Issue No.	4 (cont)	
LM End	14.13	Issue Type +	Ma	Location *	LS	
Category	Earthen Levee			GPS Latitude/Longitude		
				Start		End
Item	Underseepage Relief Wells			38.947628 °		38.947628 °
				-121.669764 °		-121.669764 °
DWR ID	DWR_RD1500_02_s_2012_4					
Comment Code						
Inspector Comment						
The concrete pad and the PVC underneath are broken apparently by an attempt to pull out the head of the well.

View of the relief well at historical boil 12. Fall 2015.

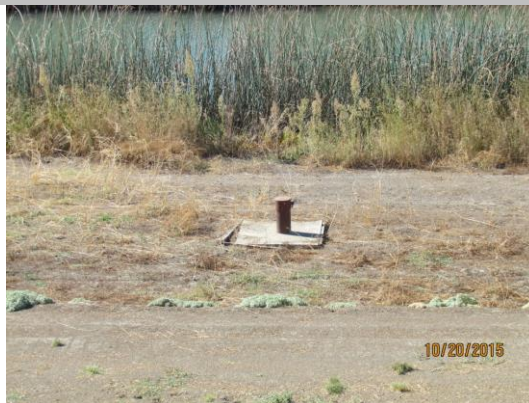
Photo 1 of 1 : SP_2019_RD1500_190_11_20190304_00004.jpg

LM Start	14.47	Rating **	A/W	Issue No.	11
LM End	14.47	Issue Type +	Ma	Location *	LS
Category	Earthen Levee			GPS Latitude/Longitude	
				Start	End
Item	Underseepage Relief Wells			38.951413 °	38.951413 °
				-121.673856 °	-121.673856 °
DWR ID	DWR_RD1500_02_s_2012_11				
Comment Code					
Inspector Comment

A relief well at historical boil 16. Fall 2015.
